DDASaccident765

DDAS Accident Report

Report date: 15/07/2011	Accident number: 765
Accident time: 12:15	Accident Date: 03/12/2009
Where it occurred: AF0308/01635/5324, Qala-e-Ahmad jan village, Bagram District, Parwan Province	Country: Afghanistan
Primary cause: Inadequate training (?)	Secondary cause: Victim inattention (?)
Class: Handling accident	Date of main report: 09/12/2009
ID original source: None	Name of source: Demining group
Organisation: [Name removed]	
Mine/device: VOG-17, 30mm rifle grenade	Ground condition: soft wet
Date record created:	Date last modified: 15/07/2011
No of victims: 1	No of documents: 1

Detailed Demining Incident Report

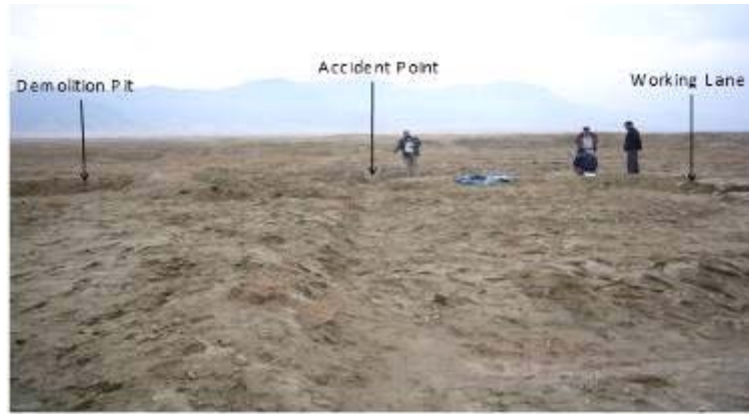
Overview

a. Worksite layout and marking. The incident location was seven metres away from the deminer's clearance lane. The area around the accident is a cleared area. Markings of the clearance lane were as per [Demining group] SOPs & AMAS. The Section Leader's location was approximately 30m away when the accident occurred. The ambulance pick up point was approximately 20m away. A sketch map is located at Annex A, in the Demining Accident Report. [Not made available.]

- a. As per the IMSMA Progress report dated 03/12/2009 one UXO had been located in the clearance lane.
- b. Details of the crater size. Diameter Approx 80cm, Depth Approx 20cm, fragments was found in close proximity to the incident site by team members. No other UXO or mines are located in the immediate area of the clearance lane where the incident occurred.

The accident occurred seven metres from the Victim's working lane, so within the safety distance for the threats, but the investigators were photographed at the site without wearing PPE. This sets a regrettably common example of double standards.
